Manhole Inspection Summary

Manhole # S35Y__001MH

Insp Date: **3/26/08 9:29 AM**

Location Address: **1916 rear**

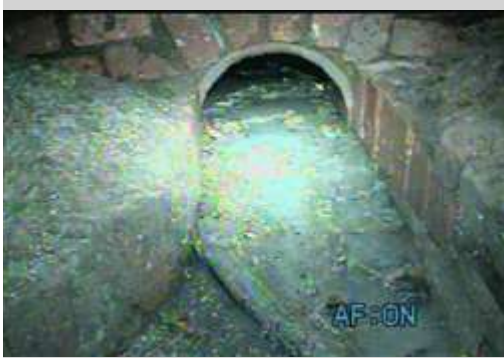
Defect 2

Condition: ☐ Sound ☐ Cracked ☐ Root Intrusion ☐ Deteriorated ☐ Leaks ☒ **Debris**

Bench and Channel Debris

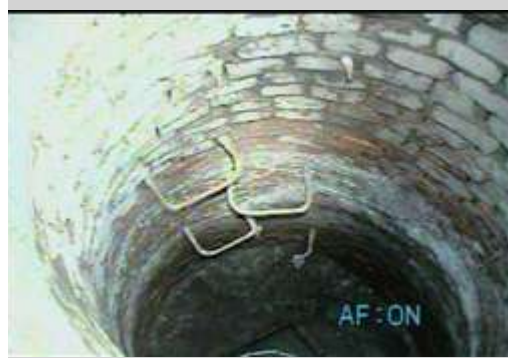
Defect 1

Condition: ☐ Sound ☒ **Cracked** ☐ Root Intrusion ☐ Loose Brick ☐ Deteriorated

Infiltration: ☐ None ☐ Joint ☐ Cracks ☐ Mortar ☐ Roots ☒ **Wall**

Steps Count: **5** Missing: **2** ☒ **Corroded**

corroded stairs, cracked corbel, corbel infiltration

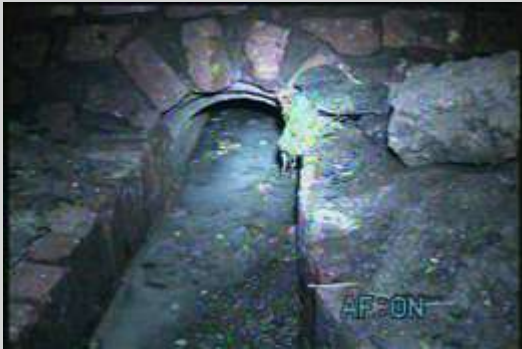
12 O'Clock Outflow

8 in. Circular Gravity Sewer
Pipe Out @ 12 O'Clock

Deposits: ☐ None ☐ Mud ☒ Sludge ☒ Debris ☐ Grease

Silt Depth: 2 (in.) Deposits Extent: Medium

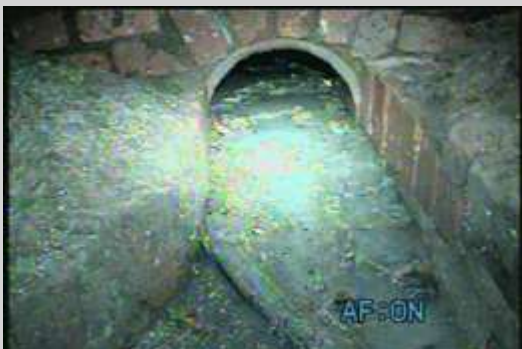
4 O'Clock Inflow

8 in. Circular Gravity Sewer
Pipe In @ 4 O'Clock

Deposits: ☐ None ☐ Mud ☒ Sludge ☒ Debris ☐ Grease

Silt Depth: 4 (in.) Deposits Extent: Medium
